Standing Seam SS150
Internal Corner with slip flashing
Scale: Issue Date:

Document Name: SST-IC1

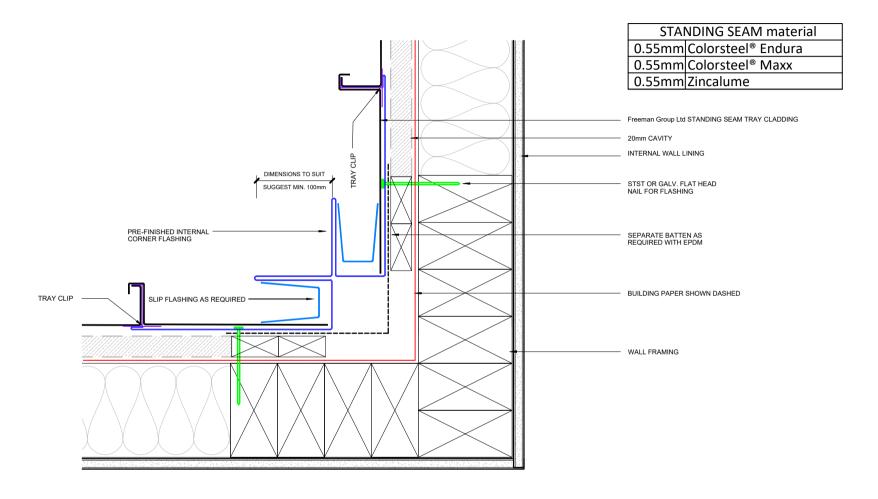
These details are required to be fixed to allow thermal movement .
